## Case Study: Root Barrier Installation Verwood, Dorset

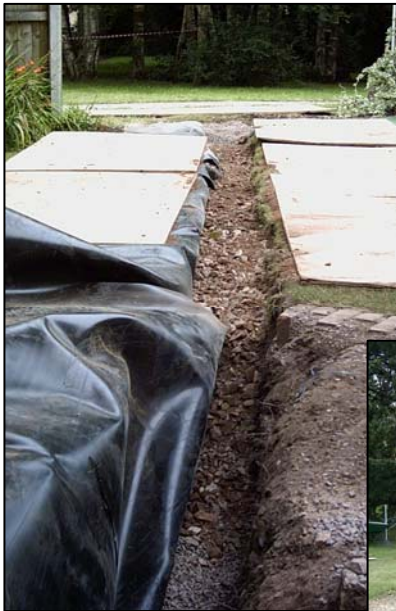
- Initial application to remove protected trees damaging an attached garage
- Insurers rebuilt the garage on raft foundation (approximate expenditure £50k)
- 1 year later further movement occurred which also affected the main dwelling
- Further application made to remove trees – refused. Subsequent appeal to Secretary of State dismissed

- Insurers approached the Authority concerning possibility of root barrier installation – The Authority considered the proposed excavation to close to the protected trees – Insurers faced with underpinning costs of approximately £125k

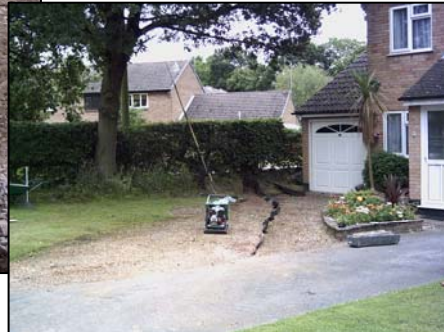
- MT Environmental Groundworks team are instructed to open discussion and negotiation with the Authority and suggested undertaking air spade investigations to establish root distribution – The Authority agreed that it was the only true way of establishing viability

- Air spade investigations carried out by MT with the pits inspected by the Authority - all agreed that the proposed installation would not have detrimental affect on tree health and that the root barrier could go ahead following a consent application
